Manhole Inspection Summary

Manhole # S04WW1016MH

Location Address: **4001 FORDHAM DR**

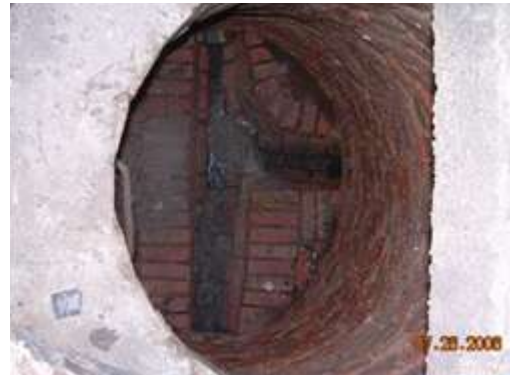
Top View

Corroded steps. Corbel infiltration.
Evidence of surcharge - Bench debris.
Channel debris.

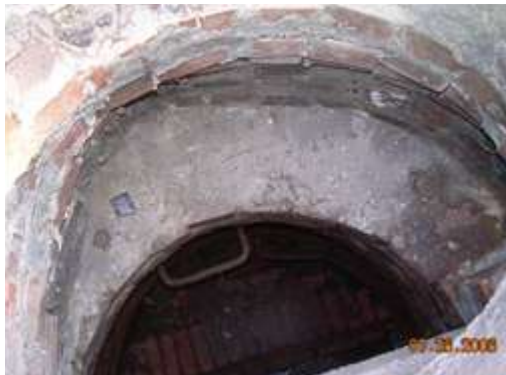
Corbel/Barrel offset

Corbel/Barrel offset. Adjustment
infiltration. Corroded steps.

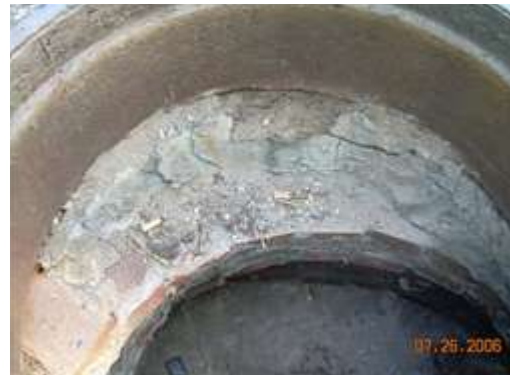
Defect

Frame offset. Frame leaks. Adjustment
deterioration, loose brick and infiltration.

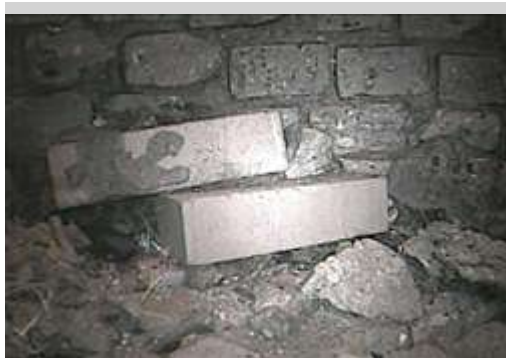
Defect

Bench debris.

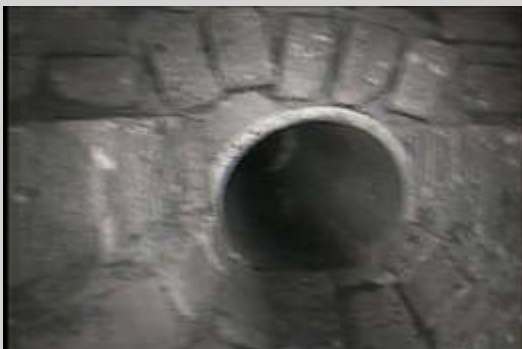
8 in. Circular Gravity Sewer Pipe In @ 3 O'Clock

Barrel deterioration and infiltration.

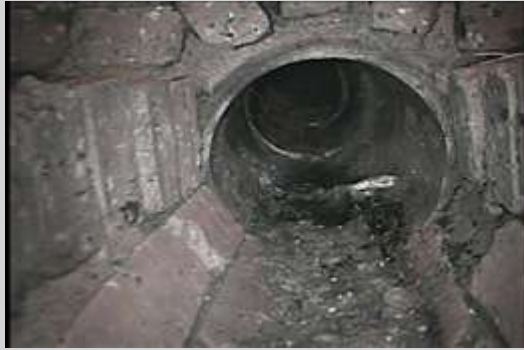
Pipe In @ 6 O'Clock

Channel deterioration.
